Spherical Roller Bearings and Overhung Fans.

A case history in condition monitoring, root cause analysis, and design.

By Rod Bennett, Practices Leader Condition Monitoring. Silcar.

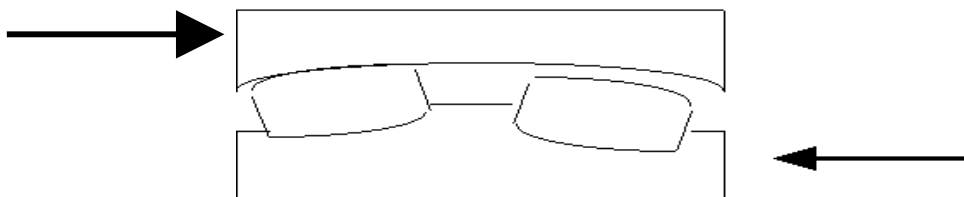
When this ratio is not met, the axial load displaces the inner race relative to the outer race, as shown below.

When this happens, the row of rolling elements at the drive end of the fixed bearing loses contact with the outer race. This deprives these rolling elements of the guidance normally afforded by the outer race. These rolling elements are then free to move around in their cage pockets, causing wear and ultimate failure of the cage. The end result is a flaming wreck.

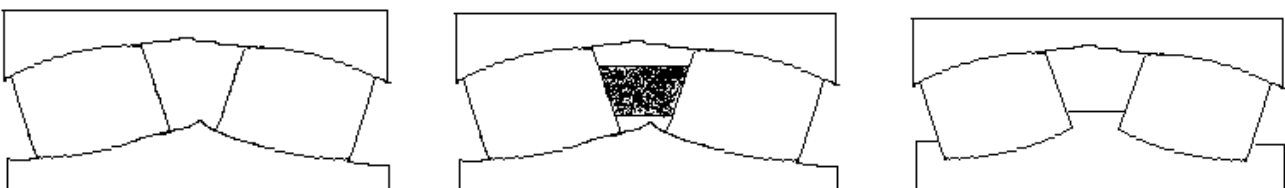
There are a number of different internal configurations available. My experience is that while none of them provide a real solution, the configuration shown on the left is the least satisfactory, while the one on the right is the most satisfactory.

1. Choose a bearing with an internal configuration that provides good roller guidance.

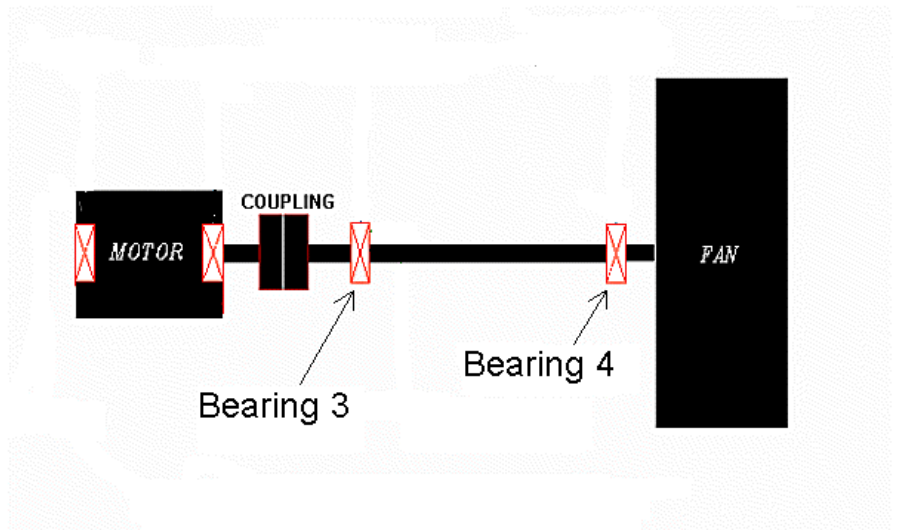
The answer is Bearing 4, as it will have the highest radial load.

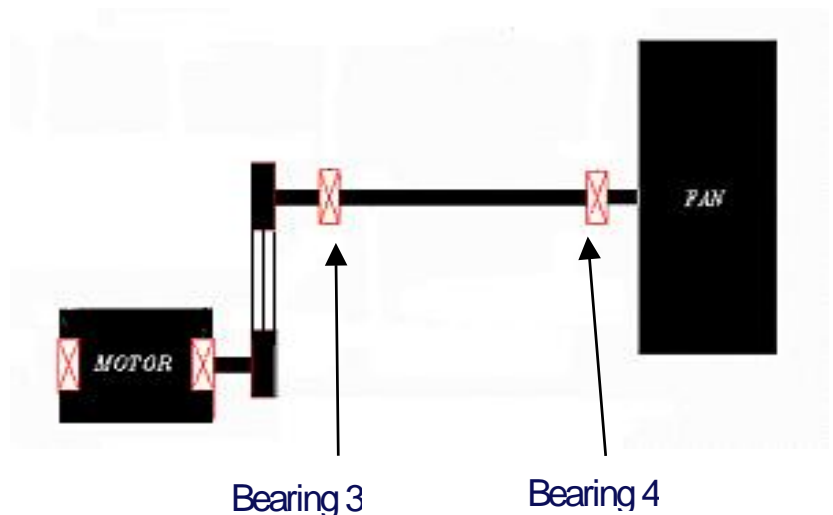
The answer is bearing 3, as it will have the highest radial load.

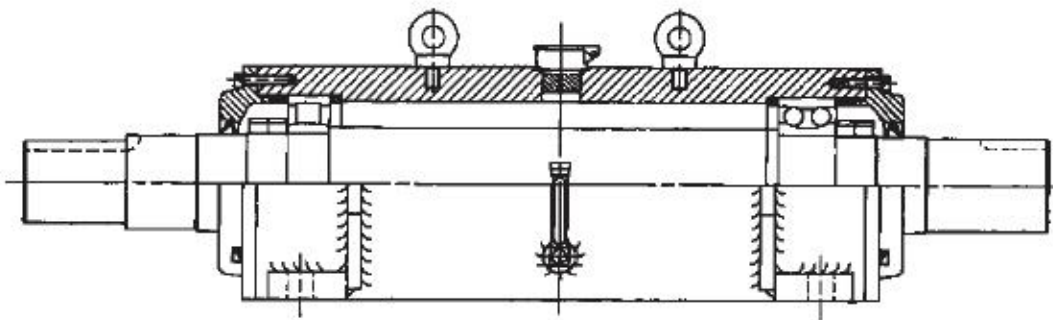
This arrangement may have an angular contact bearing and a cylindrical roller bearing as shown, or, as in our case study, an angular contact bearing and a ball bearing.

then the answer is to install a single line bored housing with 2 non self aligning bearings.
The SKF catalogue even says that these housings were developed for overhung fan applications.

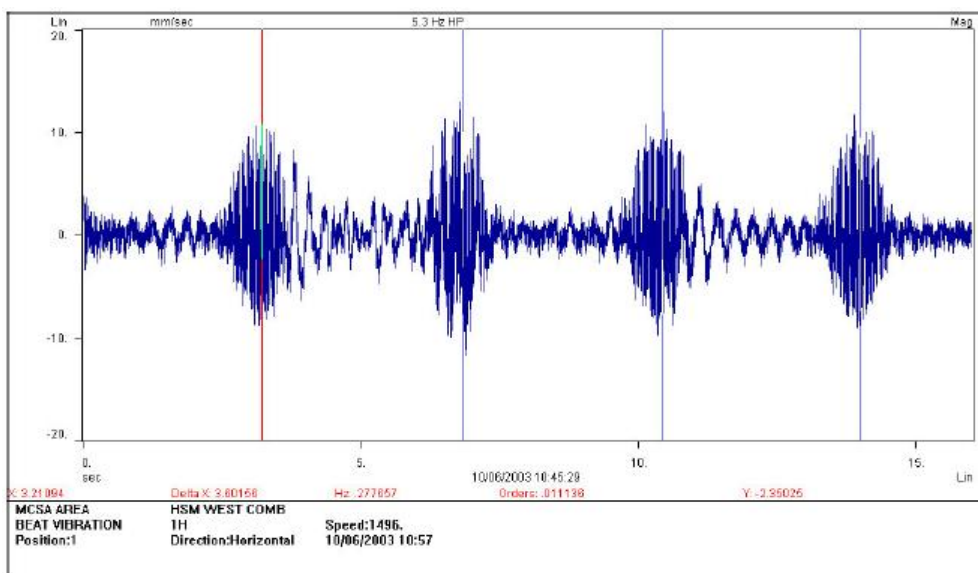
The initial symptom in both cases was a step change in the overall vibration that fluctuated in amplitude. The symptoms on the east blower were unusual in that the vibration was in the axial direction rather than the more typical radial direction. Investigations showed that the vibration was being modulated at the Pole Pass Frequency. This indicated a rotor problem.

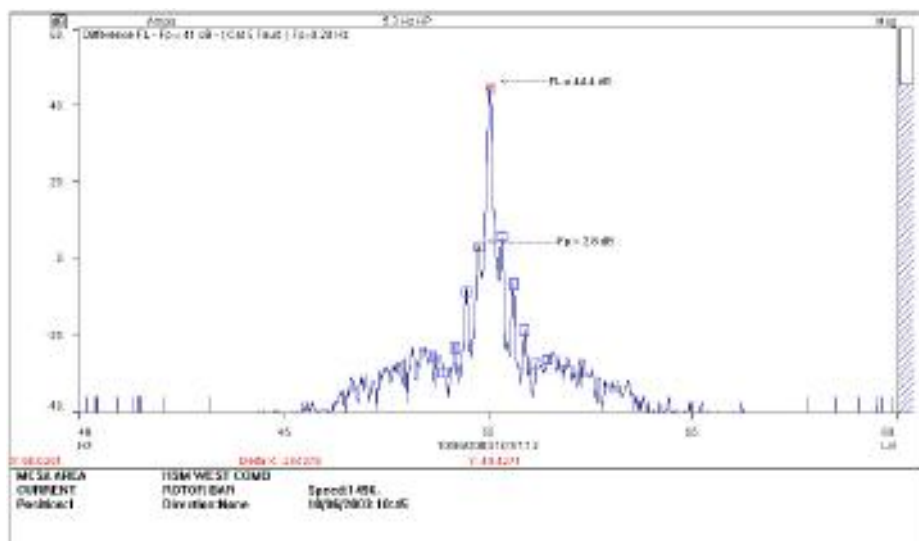
Motor Current Signature Analysis on the West blower showed an amplitude difference between the 50 Hz peak and the first lower pole pass frequency sideband of 41dB.

This suggested that we were likely to have 2 broken rotor bars or problems with high resistance joints. However, because of the low current level and our experience with the East blower, we felt it likely that the problem would be significantly worse. And so it proved to be. 10 bars were broken and all of the remainder were cracked.
