Damage Assessment Scope

Newcrest's Inspection requirements:

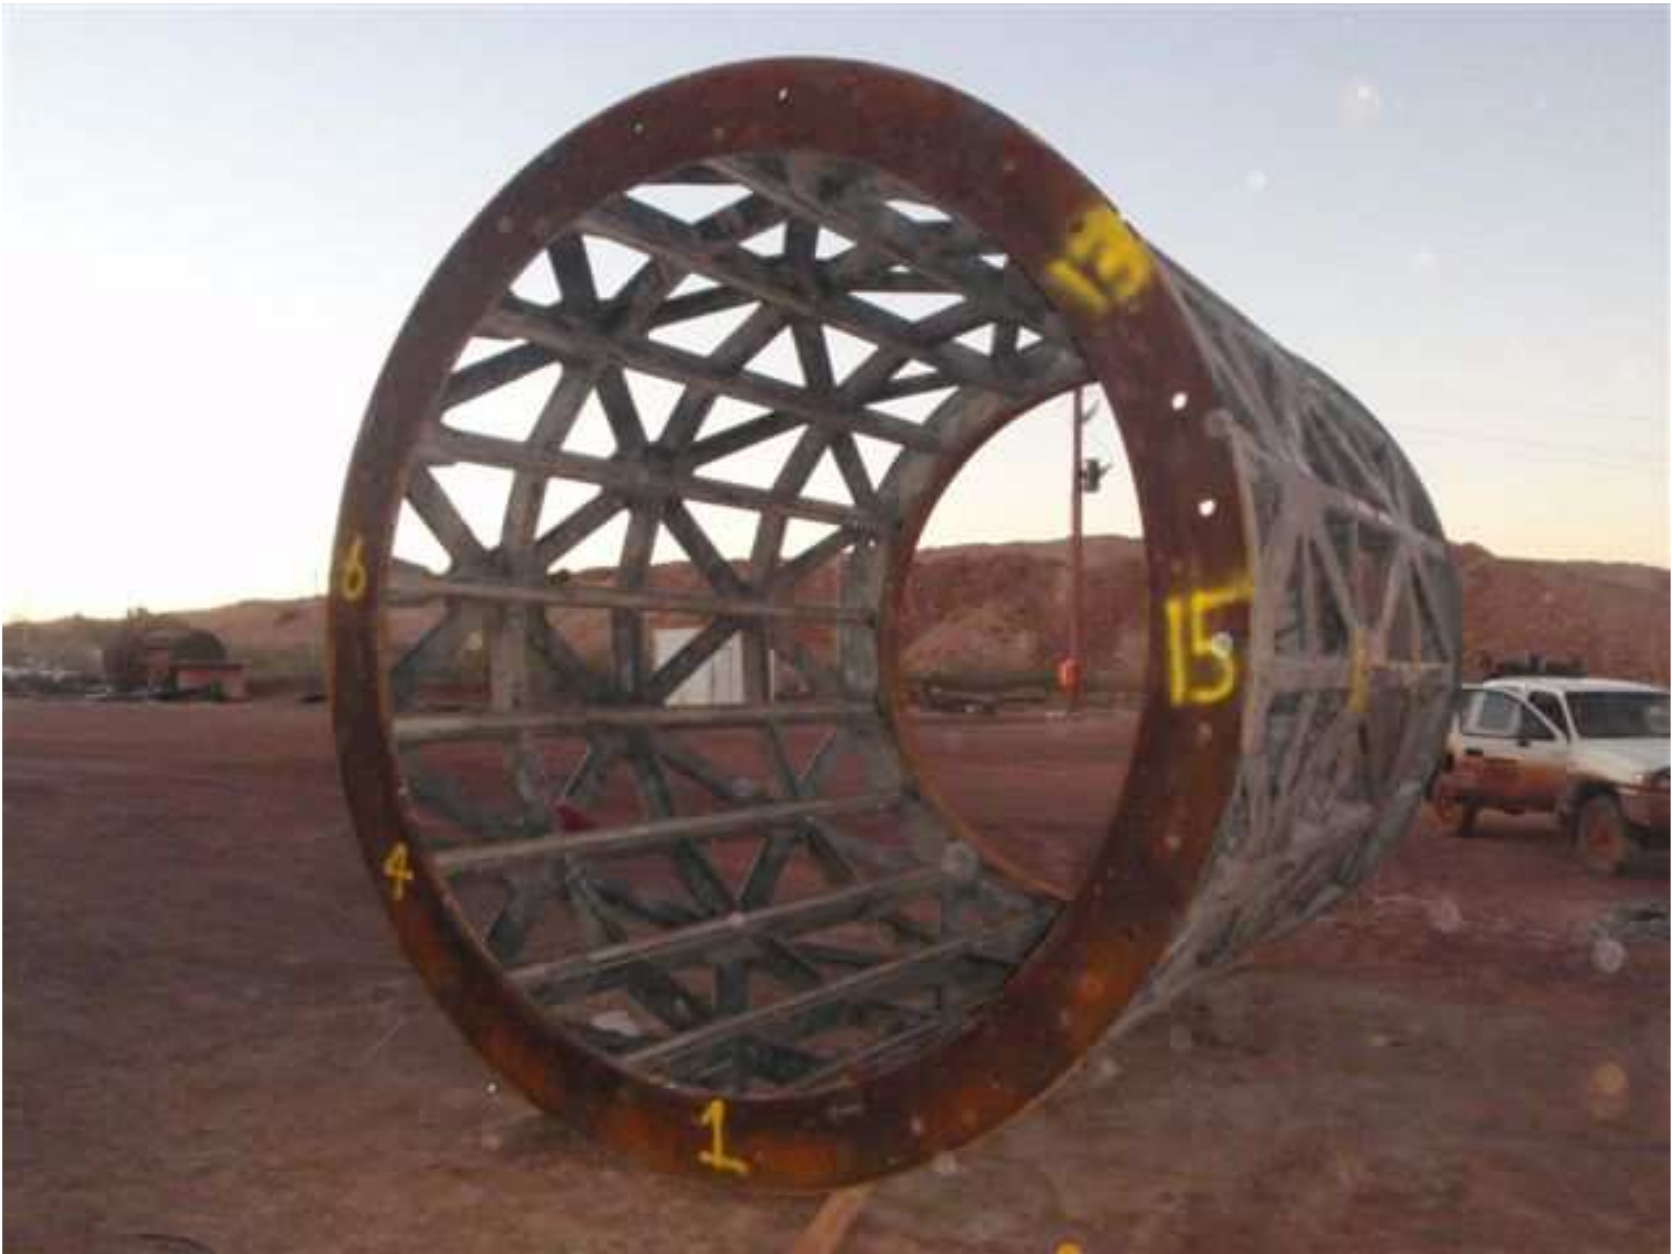
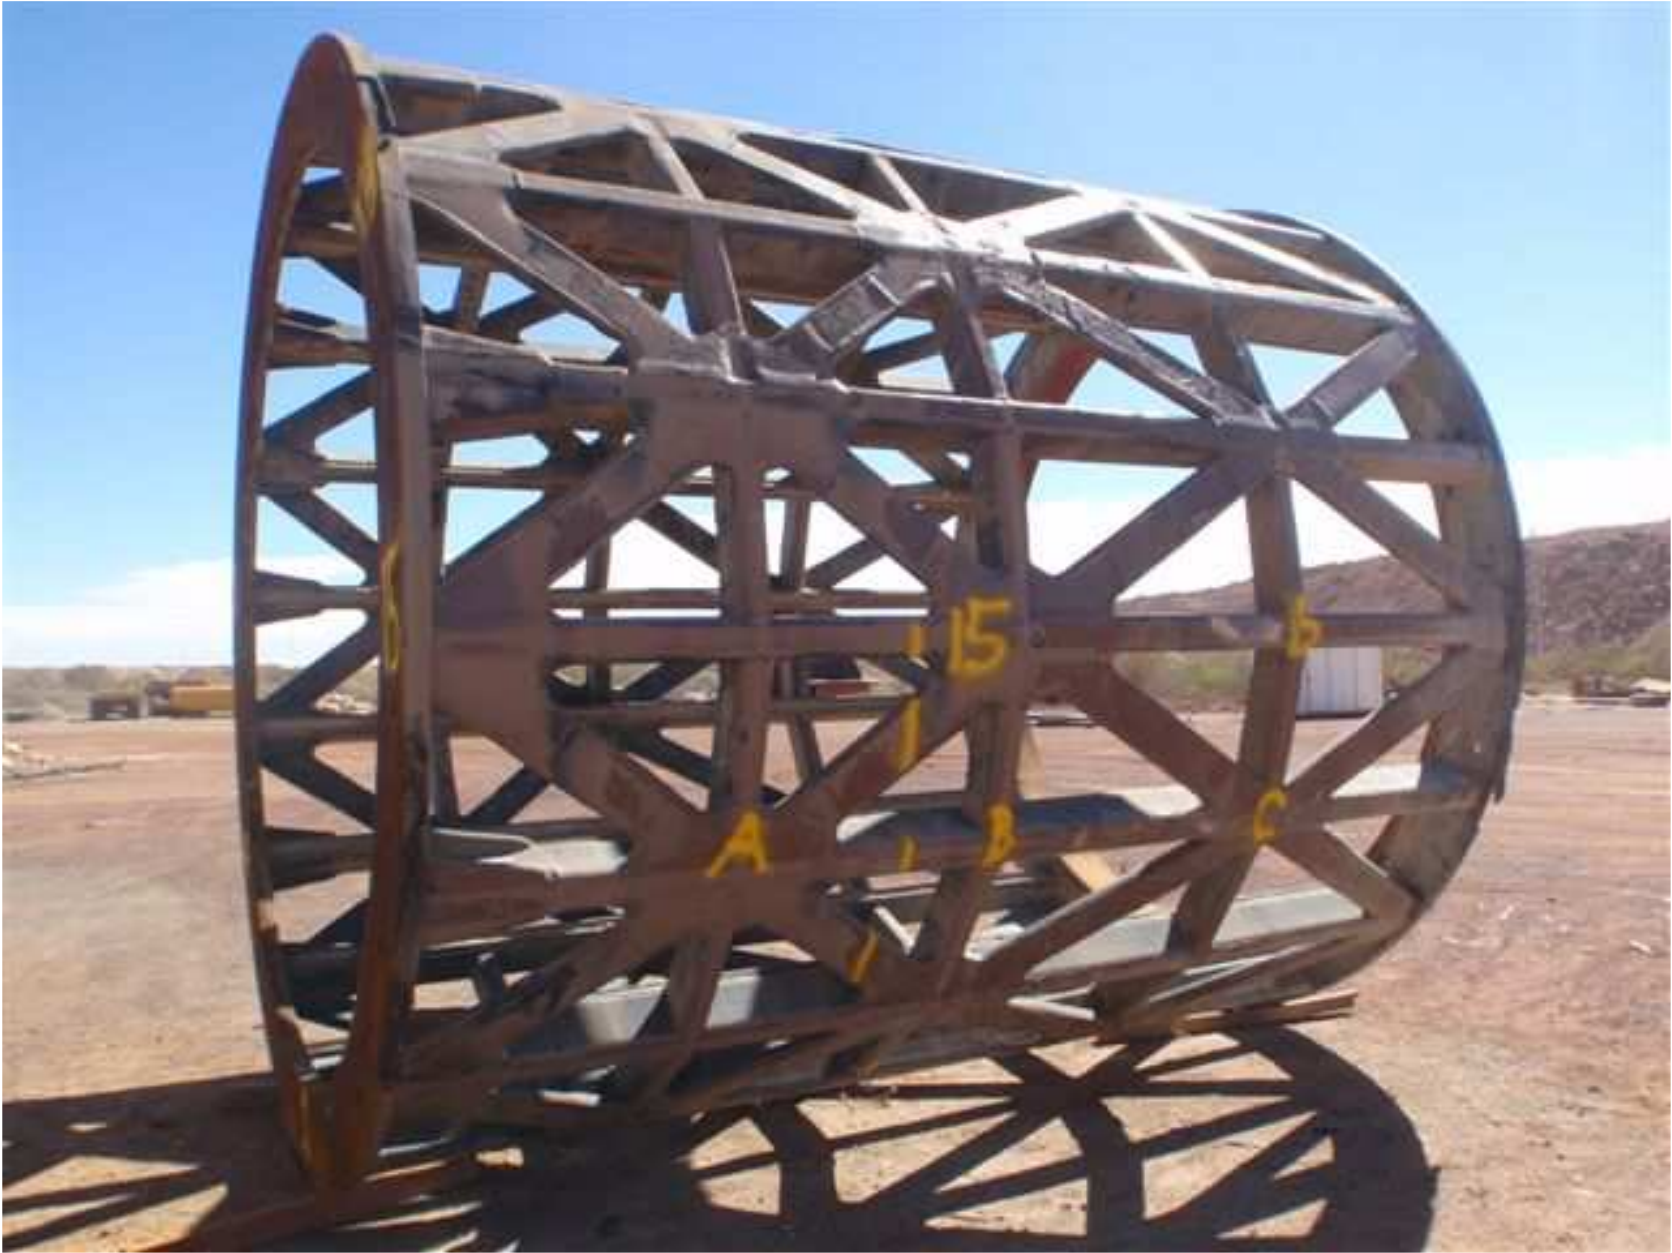
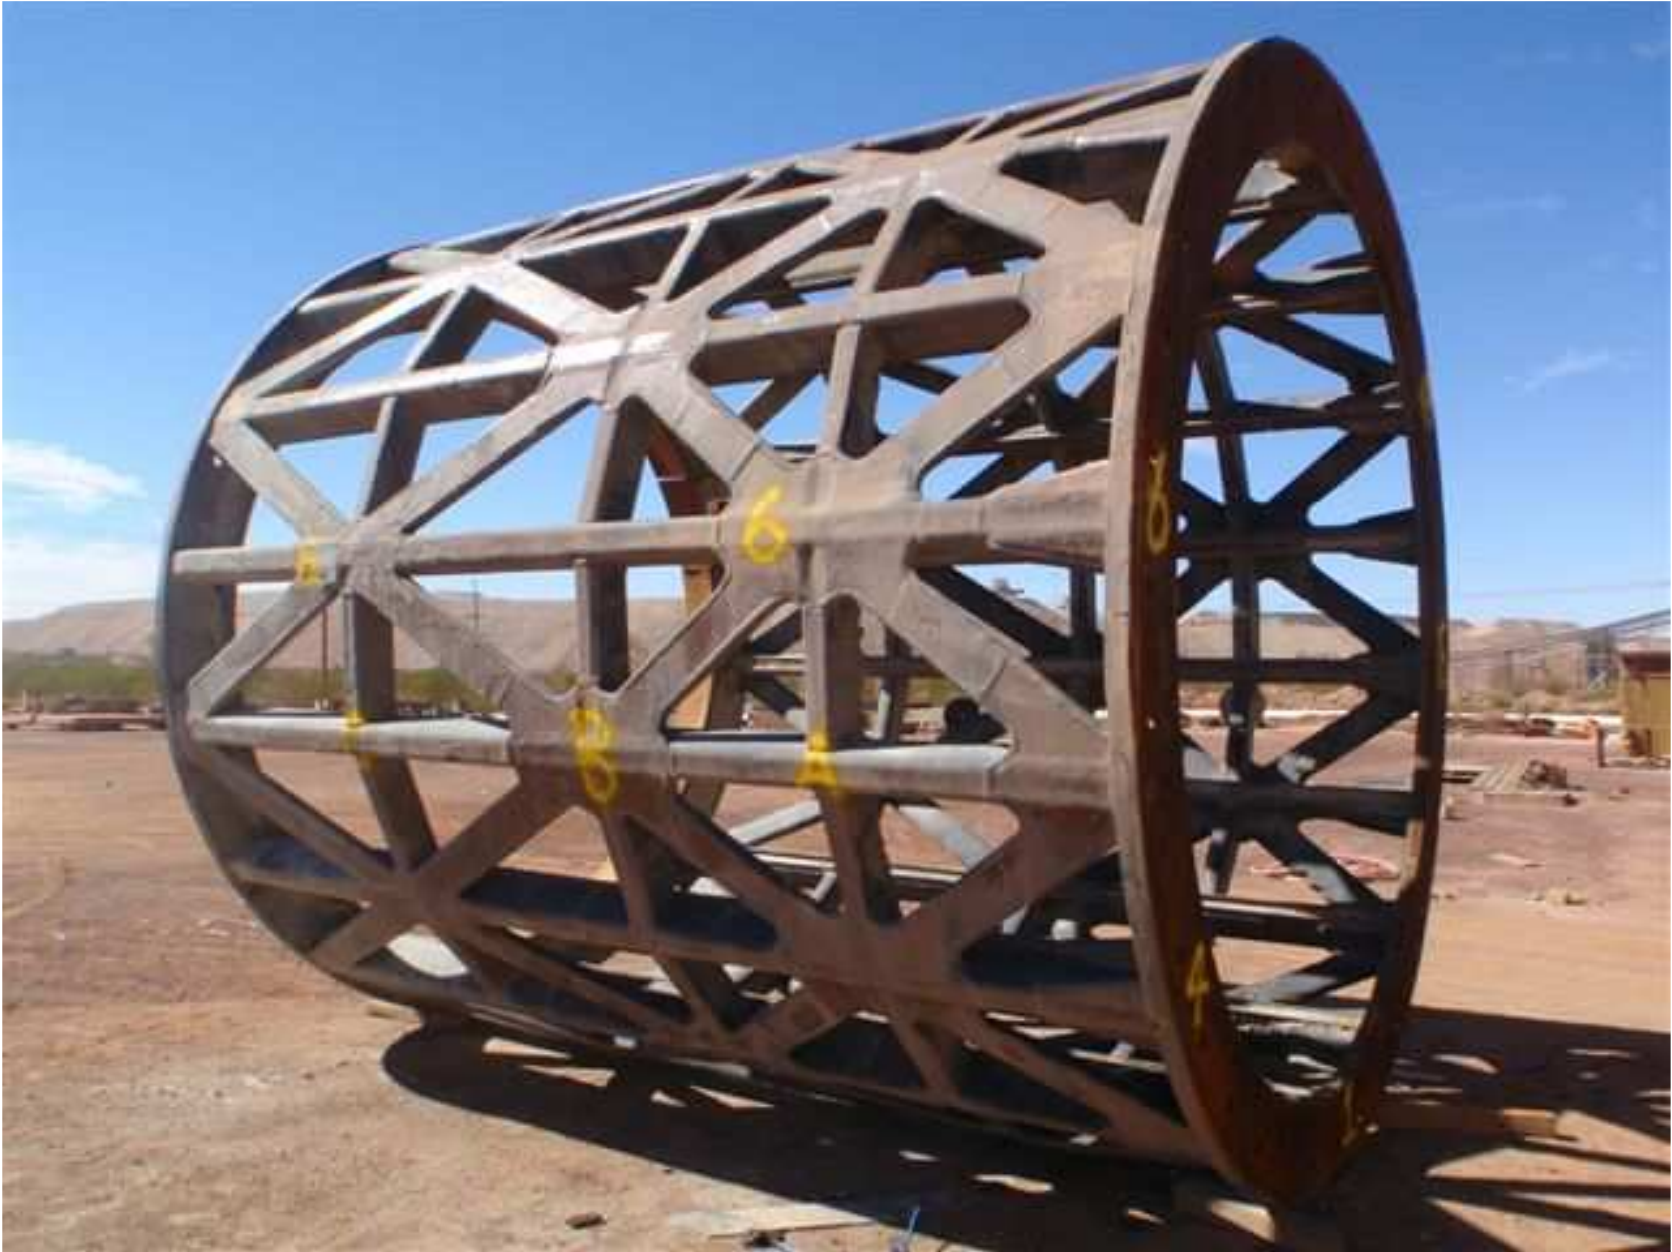
Figure 1, 2, 3 – Basic Trommel Views – identifies the radial members

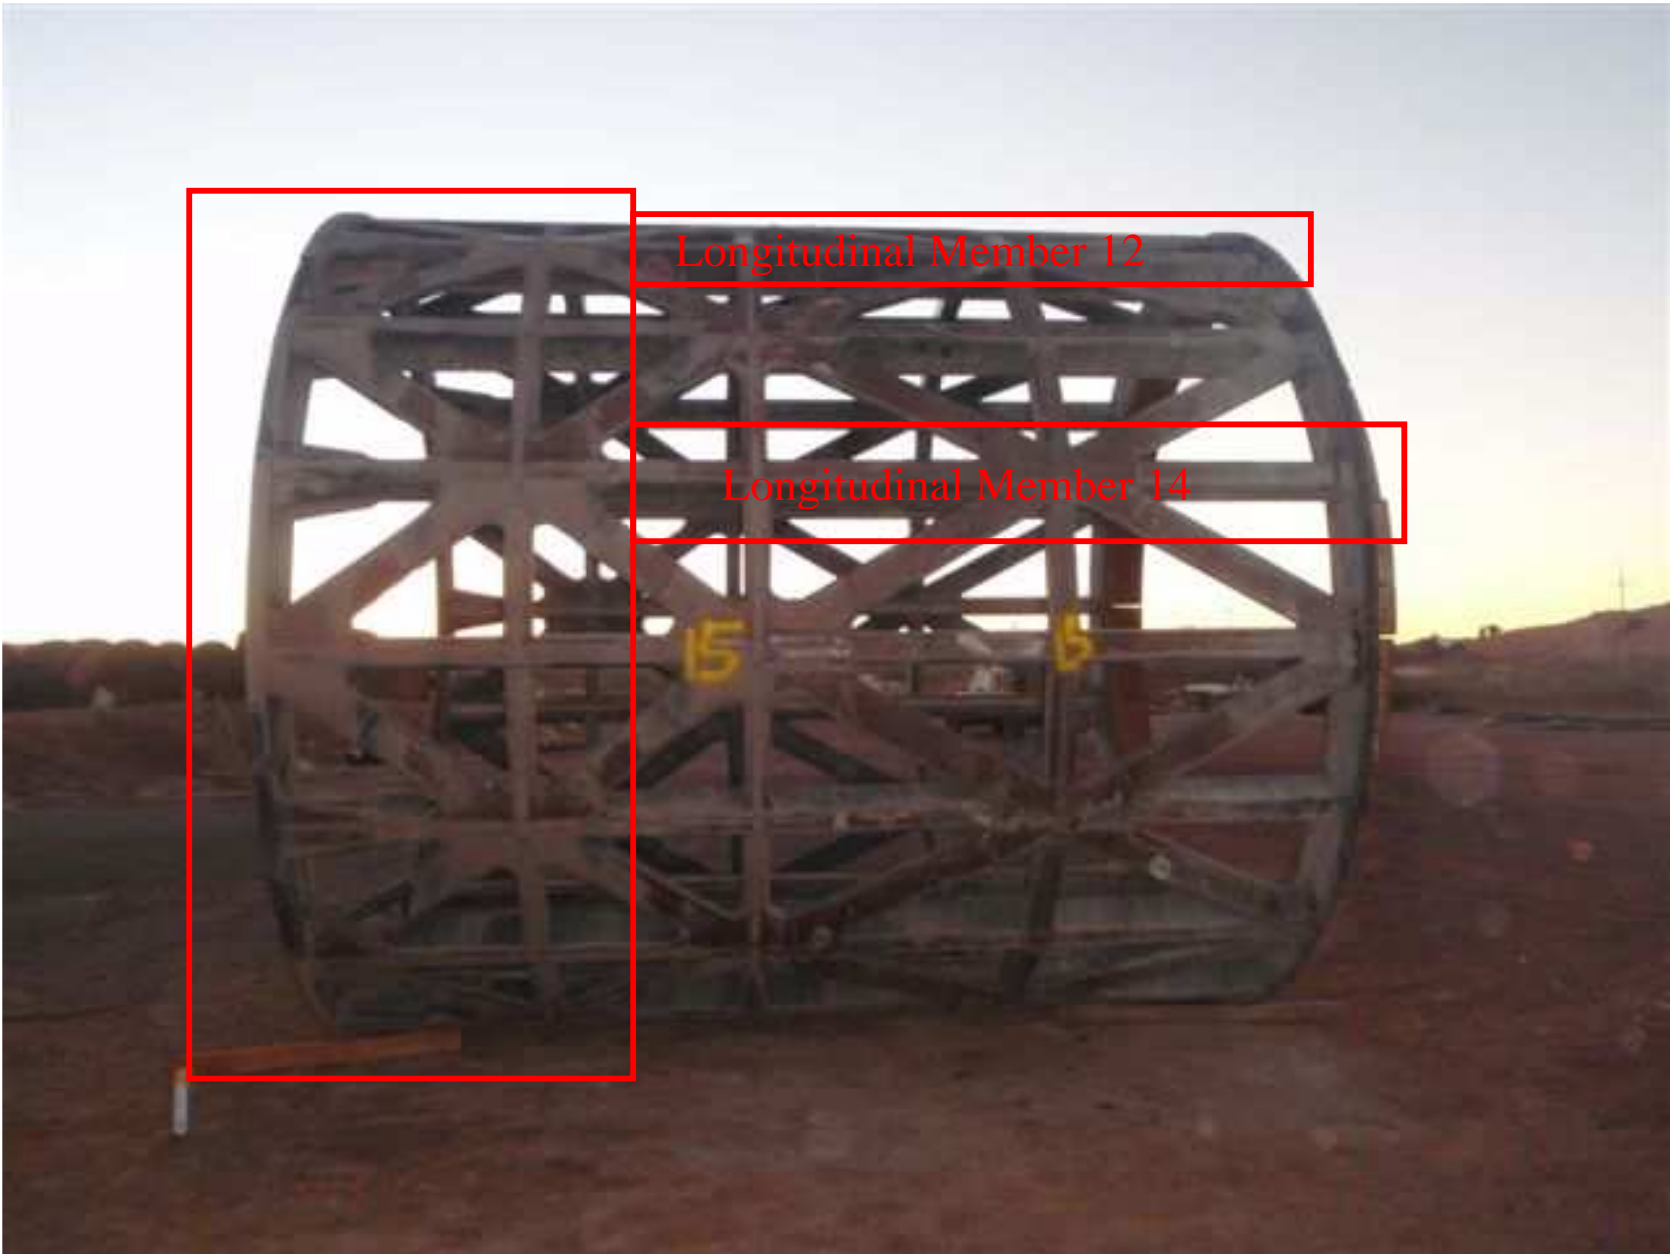
Figure 4 – Outlines the areas that require rubber strip back and testing to determine the extent of damage

1. Strip back all the rubber lining on:
 - the members highlighted by the red boxes.
 - the discharge end flange until a good rubber/steel interface is found
 - the longitudinal members – 3, 6, 12, 14
2. Thickness tests all members that have been exposed by the removal of the rubber lining.
3. NDT
 - all welds that bond members (1- 18) onto the feed end flange.
 - Welds that interconnect the structure from the feed to half way between the A + B radial members (end of rubber strip back)
 - Welds along longitudinal members – 3, 6, 12, 14 to check for cracking that has been caused by wash out
 - Exposed welds on the discharge end flange
4. Check trommel structure for extent of corrosion and other repairs that may be required to return the trommel to operation.

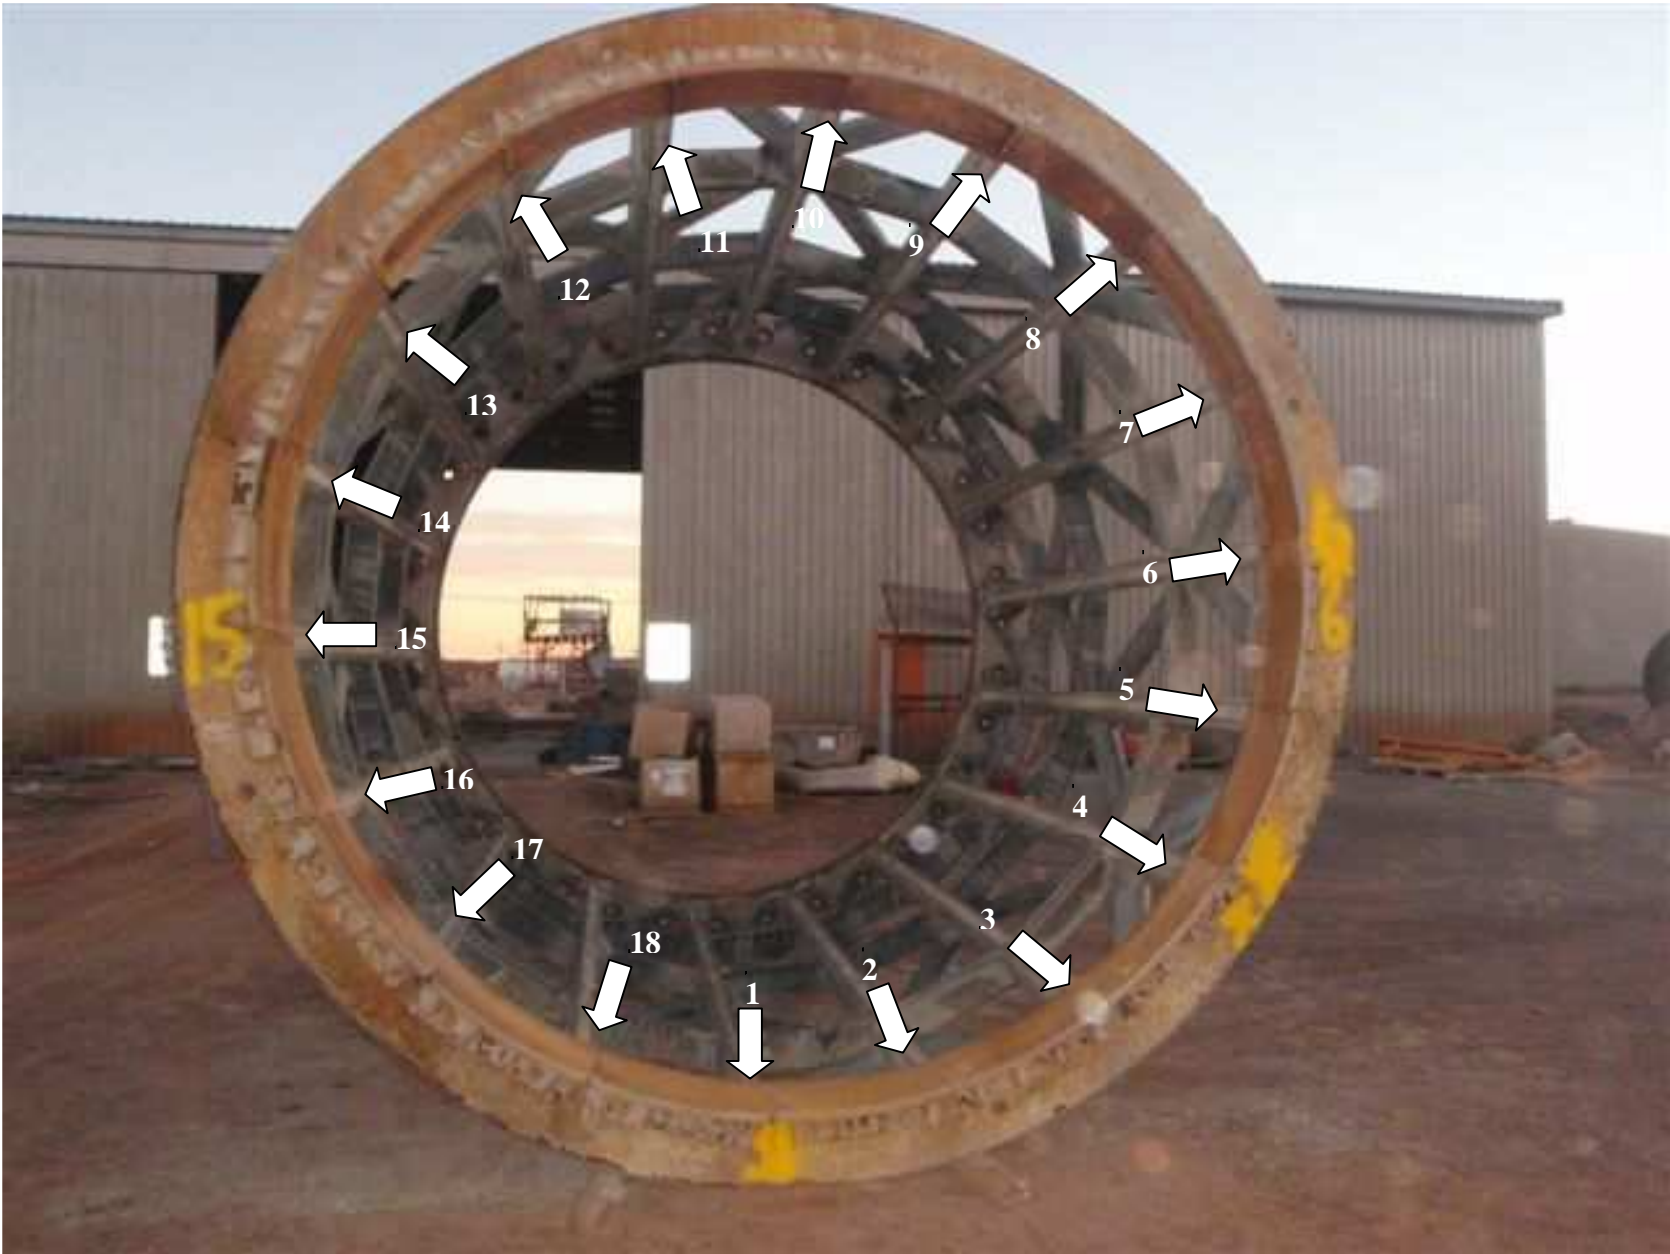
Figure 5 – Identifies the longitudinal members

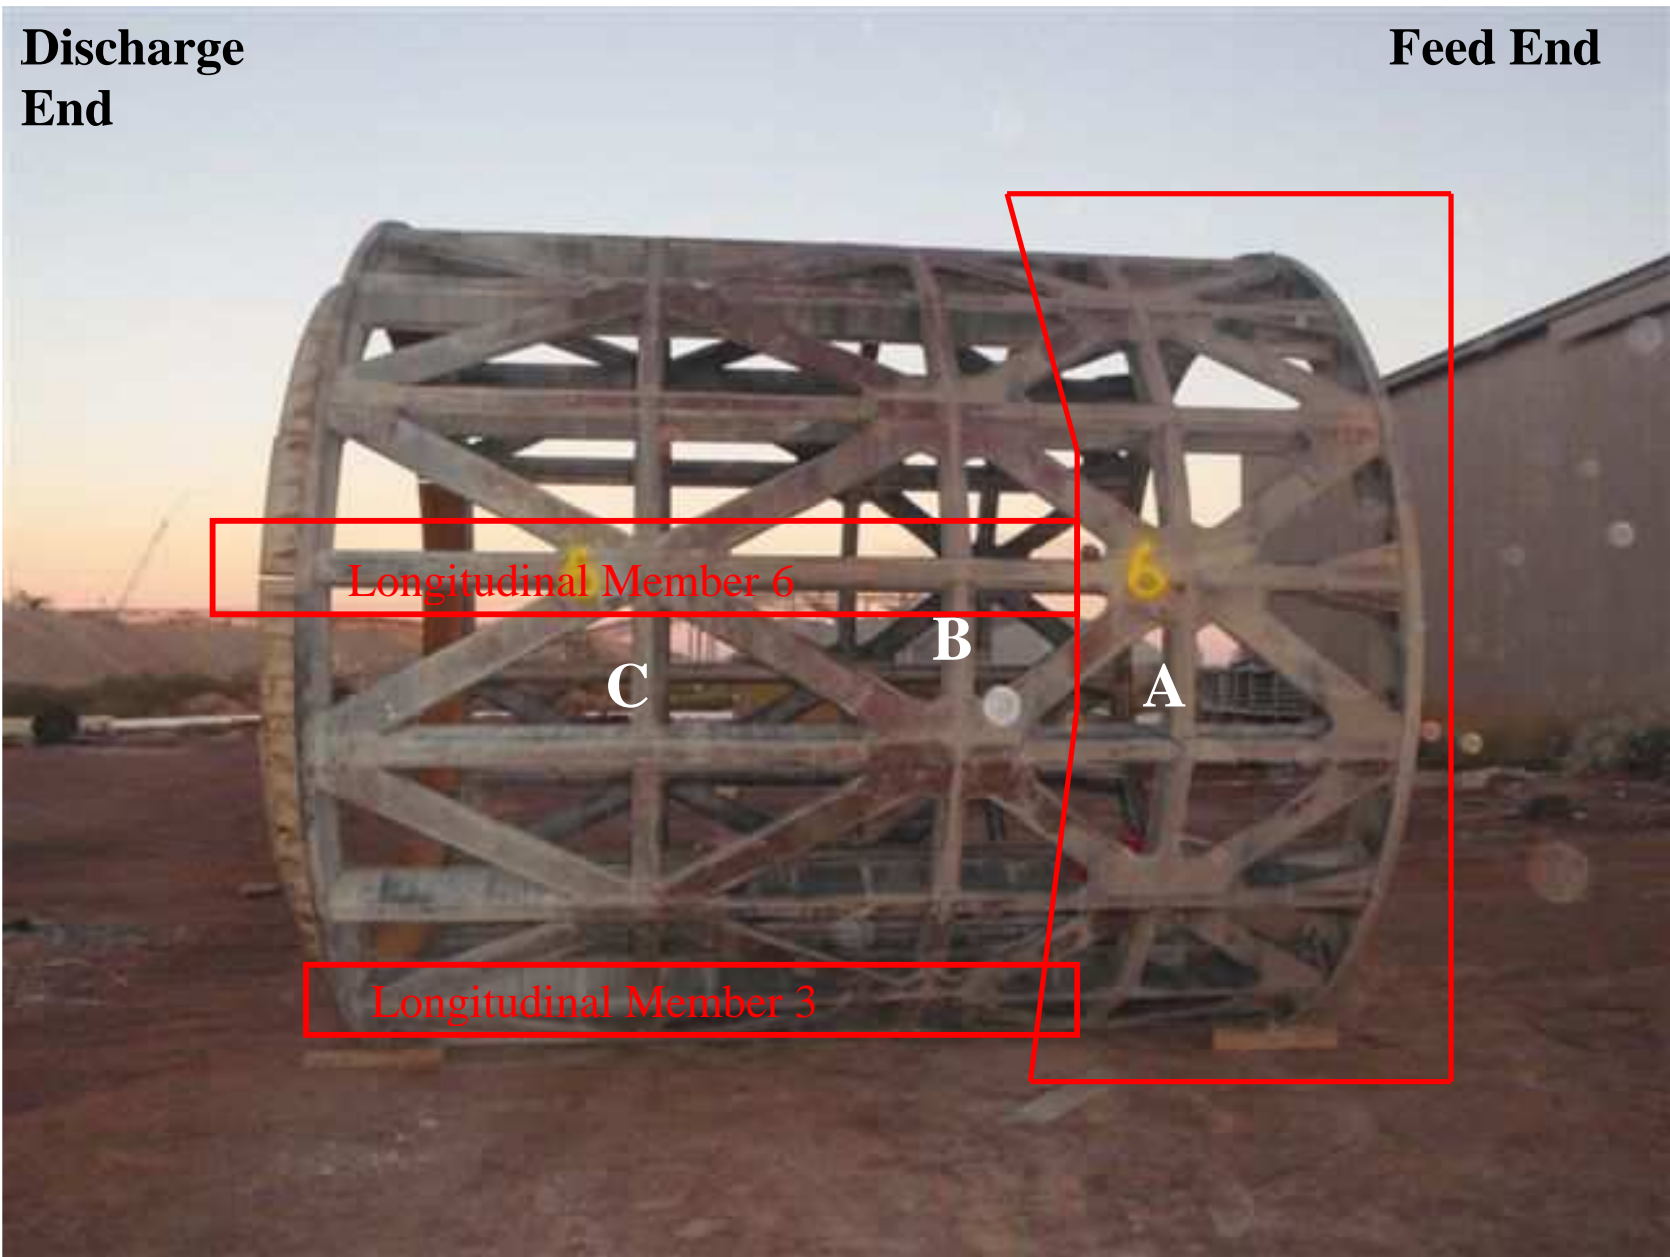
Figure 6 - Outlines the areas that require rubber strip back and testing to determine the extent of damage
