May 15, 2007

Controlling shaft voltages

By James S. Bothwell, Jim Bothwell Consulting

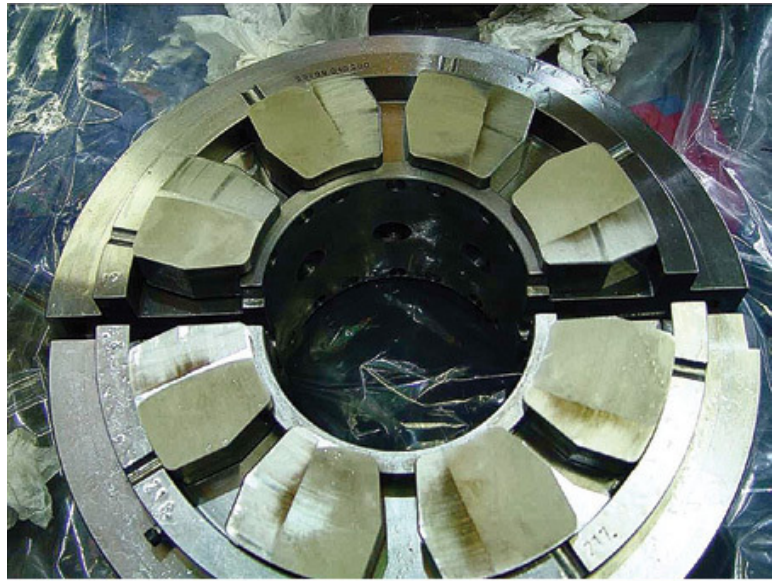
The static electrical charges produced by a turbine rotor create an effect akin to the one that results from dragging your feet across a carpet in the winter when the relative humidity is low. Touch a light switch and you usually can draw an arc. Static charges on a turbine rotor are produced primarily by moisture sliding off the last-stage blades. Being lazy, the charges find the easiest path to the turbine case and, under the right conditions, arc to the nearest component, usually the thrust bearing (Figure 1).

1. Walk a straight line. This is what a thrust bearing of a high-speed turbine looked like after six months of operation without a grounding device. Courtesy: Jim Bothwell Consulting

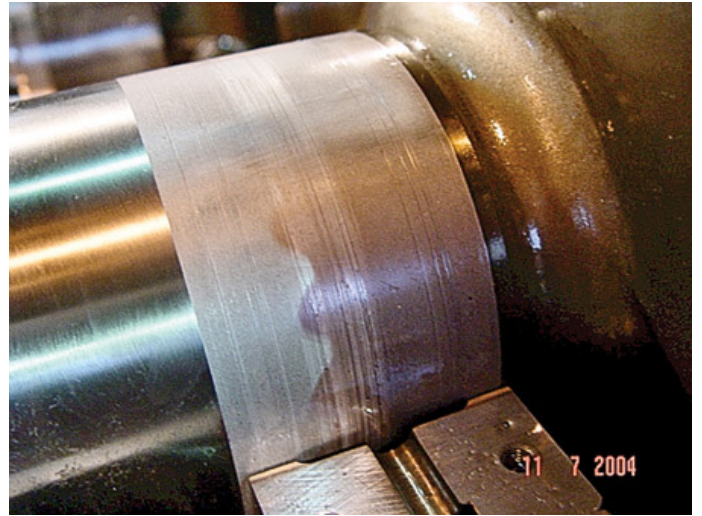
2. Decorated shaft. A "frosted" gearbox shaft. Courtesy: Jim Bothwell Consulting

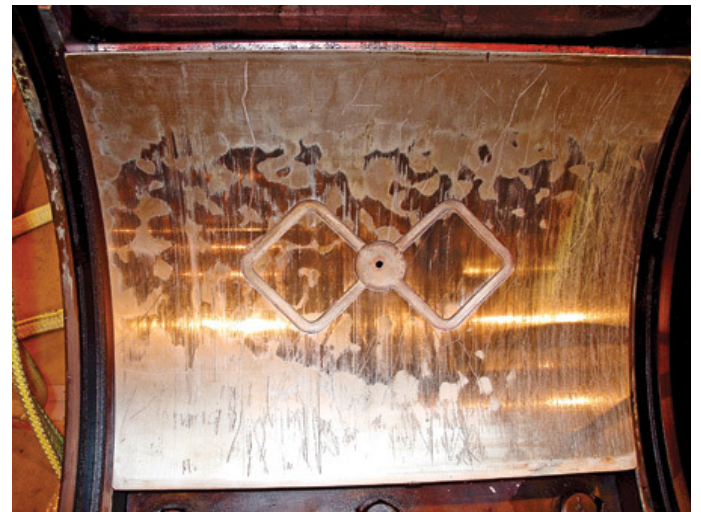
5. Bad infestation. Here are typical turbine worms created by electromagnetic activity across the shaft-bearing interface. Notice the arc weld bead effect on the bearing. Courtesy: Jim Bothwell Consulting

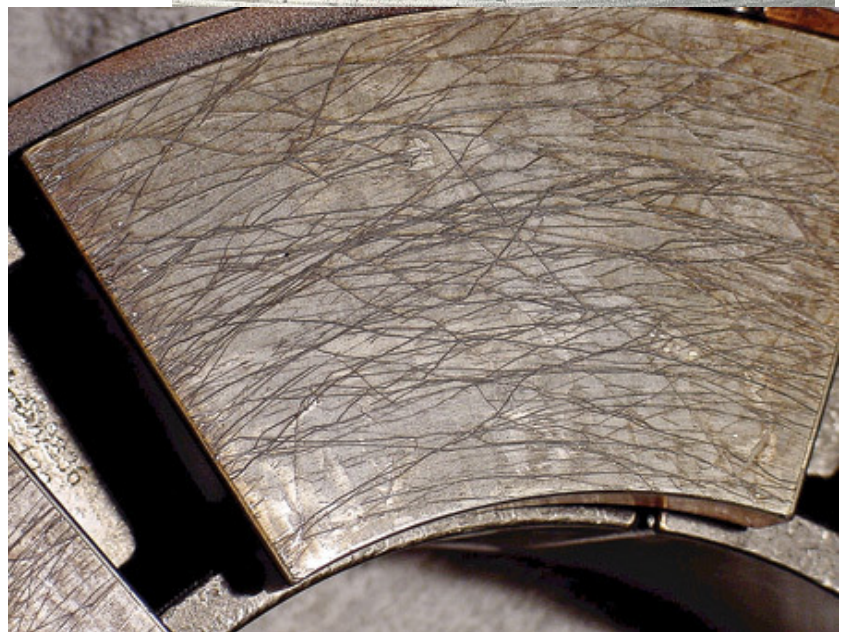
6. Night crawlers. With these

worm tracks on the thrust bearing of a high-speed compressor, note the change of direction of the electrical tracks. Dirt or contamination would cause straight lines. Courtesy: Jim Bothwell Consulting
