# Case studies in data analysis through predictive maintenance

The case studies provided in this article are actual data analyzed by the author. The case studies representing vibration analysis will present examples and comparisons of bearing faults, unbalanced conditions and impact testing for natural frequencies. Each example will be represented as a spectrum and, in some cases, a timewave form which will provide evidence of a fault that is present in the particular segment of data.

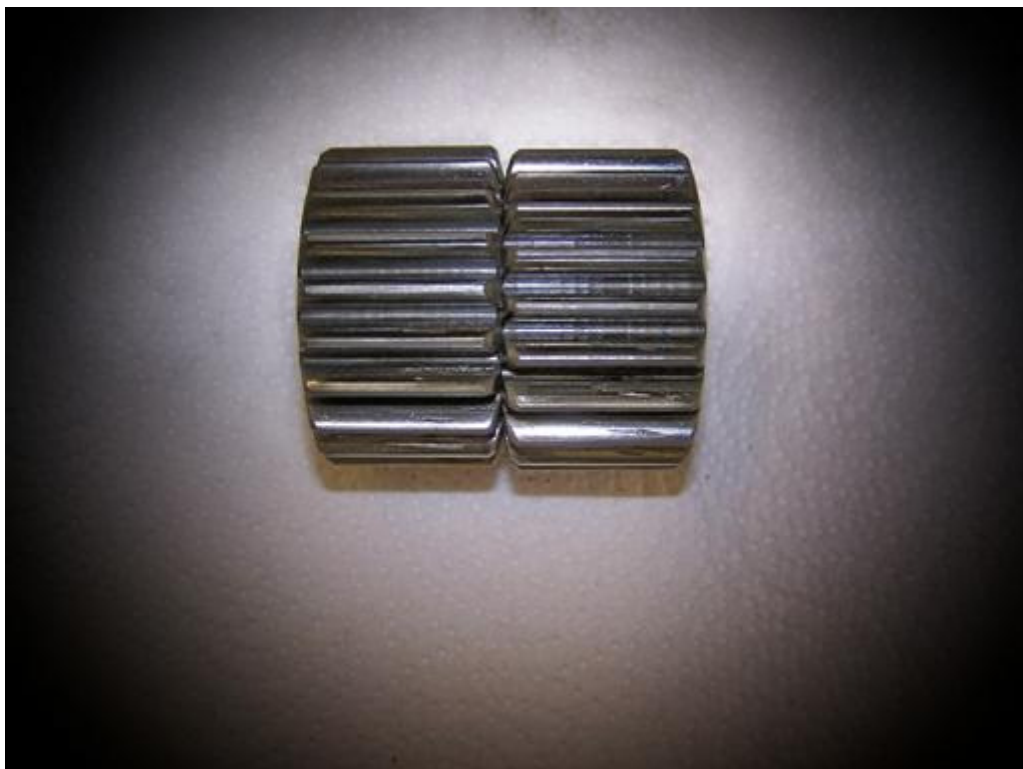
### Figure 1. Gear Mesh Data

The data shown in Figure 1 below represents a block of data collected on a planetary gearbox in a dimensional lumber operation. The frequency of interest is visible at 37,915.8 cycles per minute (CPM) with a harmonic of that frequency visible again at 75,831.6 CPM. The sidebands are clearly visible on either side of the frequency in question. The diagnostics of this problem were somewhat difficult to diagnose because of the complicity of the configuration of the gear unit. This particular unit was a planetary gear set, meaning that the input shaft (sun gear) has three gears that rotate or orbit around the sun gear, which in turn meshes with the outer ring gear.

With all of the meshing of gears inside the gear box, identifying gear-mesh frequencies can be difficult. In Figure 1, the frequencies were identified and matched to the frequencies in the spectrum. Notice the impacting in the time waveform at the bottom of the example. This is a good indication of meshing teeth with defects on the teeth.

This type of pitting and spalling on the gear teeth is caused by contamination in the oil inside the unit. The pressures between the teeth when meshing with each other can reach 300,000 pounds per square inch (psi). Sand and dirt are much harder than metal; when pressed between the teeth of the gears, they cause indentions in the teeth, leading to spalling and pitting. After the problem was diagnosed, a report was generated and the unit was taken out of service. It was sent out to a repair shop, and after disassembly, it was found that all three planetary gear units had visible defects on the teeth.

This is just one example of the benefits of predictive maintenance technologies, in this case vibration analysis. If this problem had not been detected by vibration analysis, it would have continued to progress to the point of catastrophic failure. When defects form, the gear teeth continue to grind away the metal surface, putting metal into the gearbox and creating a domino effect.

This problem could have also been detected with oil analysis. By taking an oil sample, one would have been able to detect the wear metals in the gearbox through analysis.

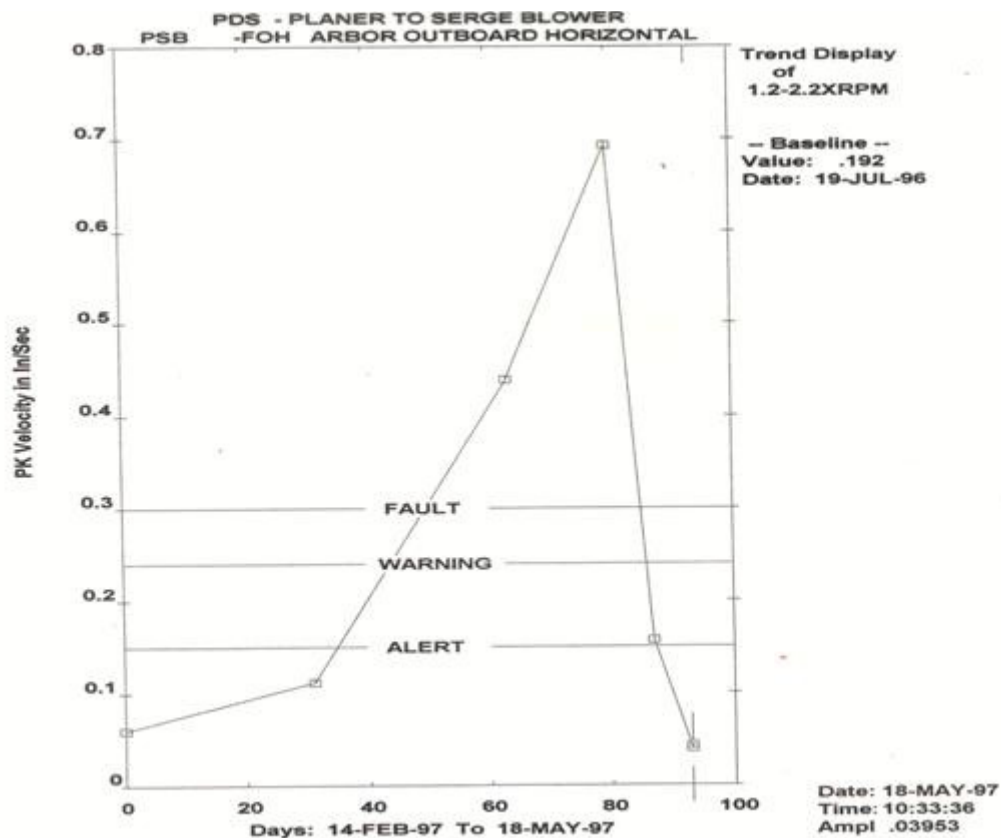
**Figure 3. Vibration Trend Data**

After completion of the balancing job shown in Figure 3, there was a drastic change in amplitude. The reduction of vibration will extend the equipment life and enable problem-free operation.

Notice the trended data in Figure 3. After balancing the fan vibration, amplitude dropped well below the alarm levels set for the machine.

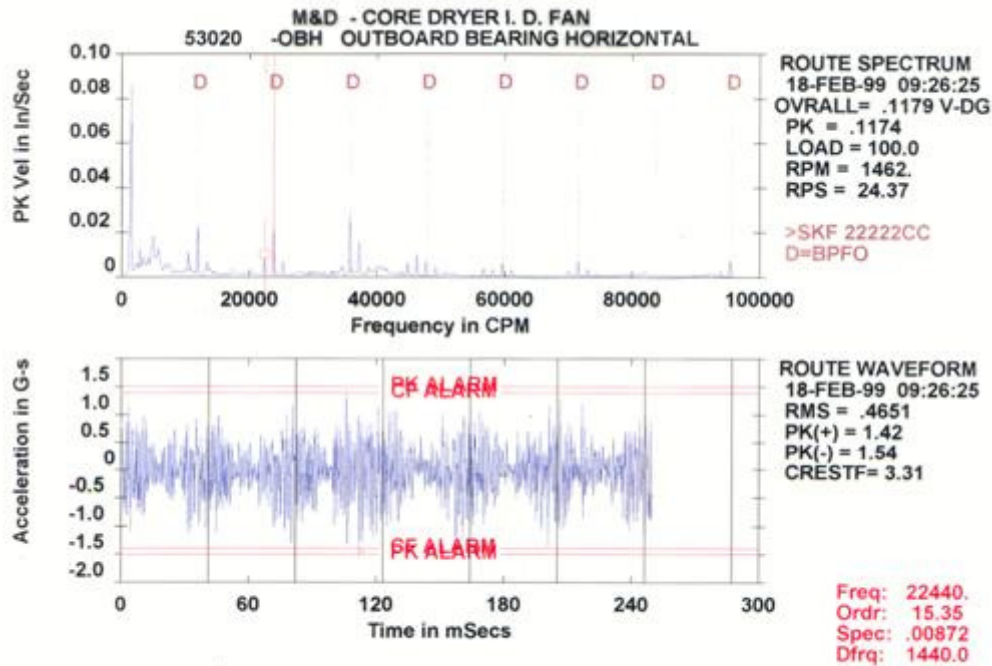
**Figure 4. Vibration Data from a Bad Bearing**

Figures 1-3 examined gear-meshing problems and the data associated with them, as well as an imbalance condition in a blower. Figure 4 represents a bearing problem with an outer race defect. Notice the side bands around the outer race fault frequency? This is caused by modulation in the time waveform. If you look at the time waveform below the spectrum, you can see the amplitude modulation that is present.

Generally, this type of modulation will represent the operating frequency of the rotating element of the machine in question.

Other information that is present on the data presented is the bearing type SKF 22222CC. This information is entered into the software to allow the software to label the fault frequencies within the spectrum. The software has a database that has more than 10,000 bearing fault frequencies calculated. This helps cut down on valuable time and makes the analyst's job much easier.

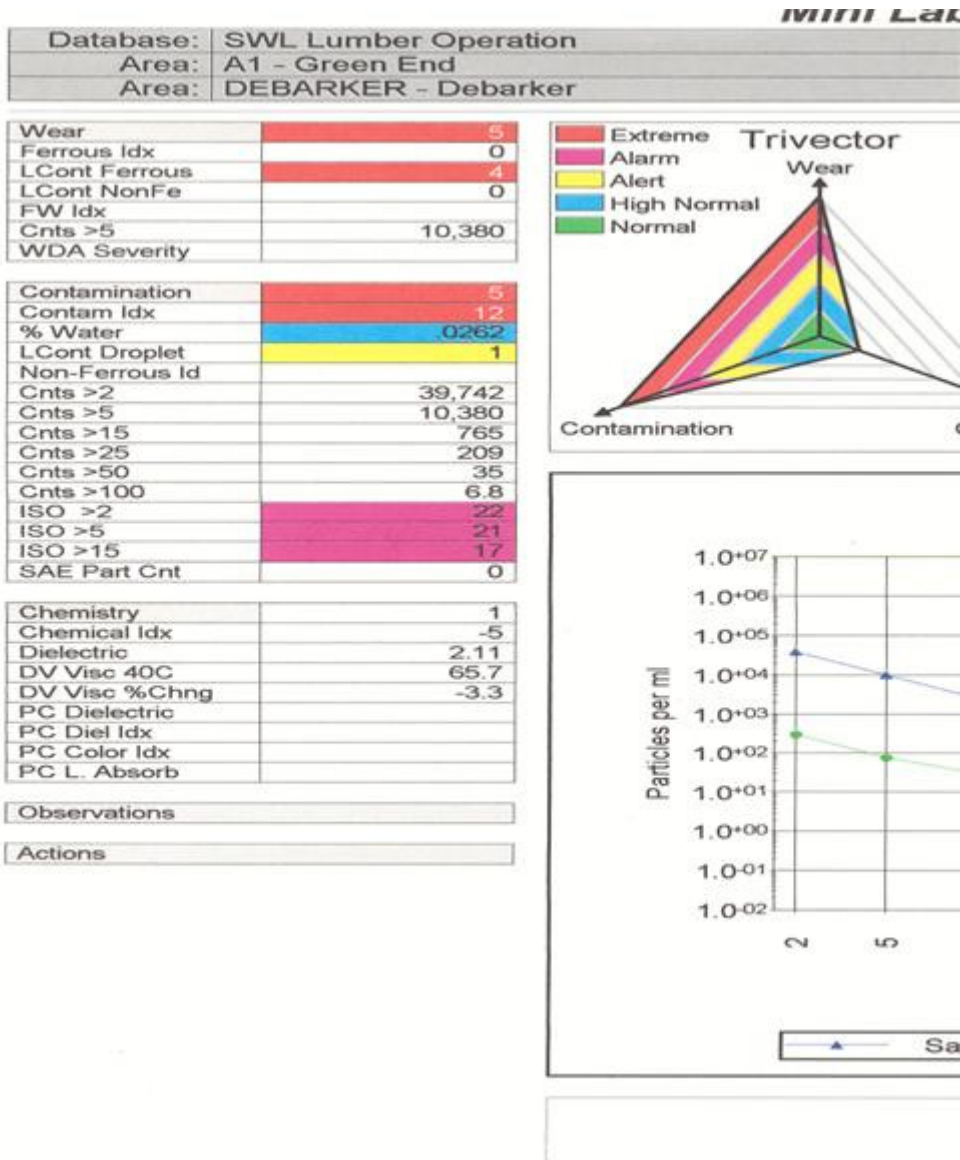
**Figure 9. Oil Analysis Data**

In Figure 9 below, the ISO contaminant level is 22/21/17. This far exceeds the standard set for all operating equipment in most industrial applications.

For each numerical increase in ISO contaminant level, the amount of contaminants in the oil doubles. If the standard is a 16/14/11, then the increase in contaminants in the oil for a 22/21/17 is 64 times dirtier than the standard.

Contaminants in oils can be prevented. Good filtration on the return side of hydraulic power units will help in taking out dirt and other ingressed particles. Usually 3-micron filtration with a 200 beta ratio is the standard set for most machinery.

Eliminating leaks and insuring that clean oil is used to refill any oil that may need replacing is another best practice that can help maintain oil cleanliness.
