**BORAL ACM Concrete Overlay
Engineering Procedure**

Document Name:	PROTOCOL FOR THE INSPECTION OF PLANT STRUCTURES
Reference:	ENG-PRO-032 r4
Issue Date:	March 2008
Author(s)	Adrian Rex & Daniel Wallace
Authorised By:	Shane Graham – National Concrete Overlay Mgr
Distribution:	Boral ACM

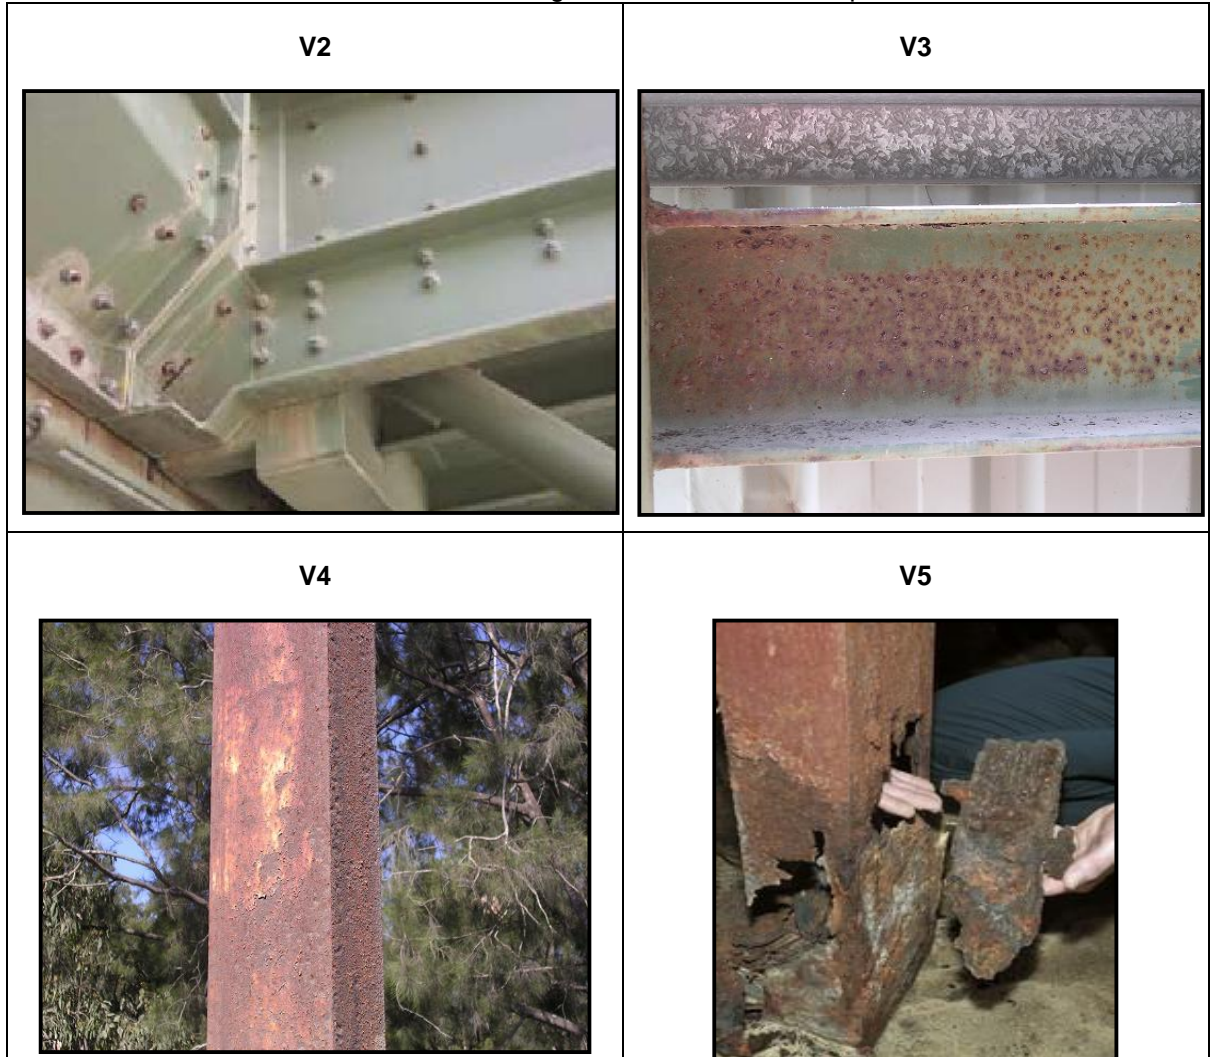
Steel condition categories – corrosion: examples

Category	Observation
V2	Minor corrosion and/or localised pitting. Possible degradation of top layer of protective coating.
V3	Corroded. Top coating of protective paint is peeling and/or flaking. Paint system broken down or some areas unpainted (loose scale to measurable pits likely on steel surface). Structurally insignificant loss of section.
V4	Advanced corrosion. Paint system totally ineffective. Significant loss of section. Holing of member. Member distorted.
V5	As V4, but failure of the member is judged to be potentially imminent. Extensive corrosion (>75% of structure). Possible loss of support section.

See Appendix B-1 for examples.

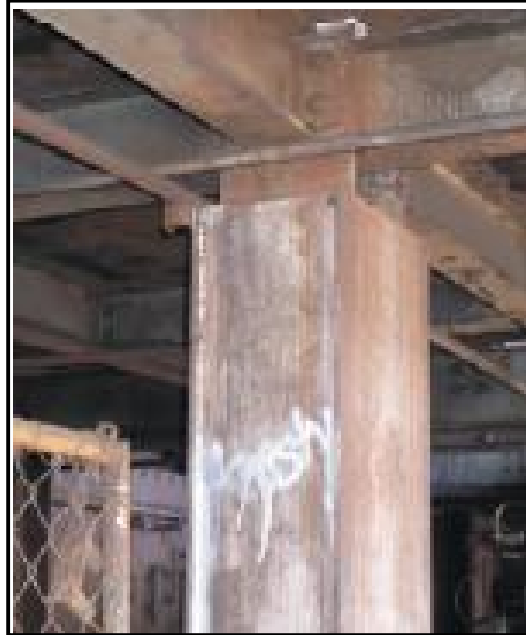
Category V3: Boxed column. Why has a boxed column been fabricated? Has the column-beam connection been designed? Further investigation required.

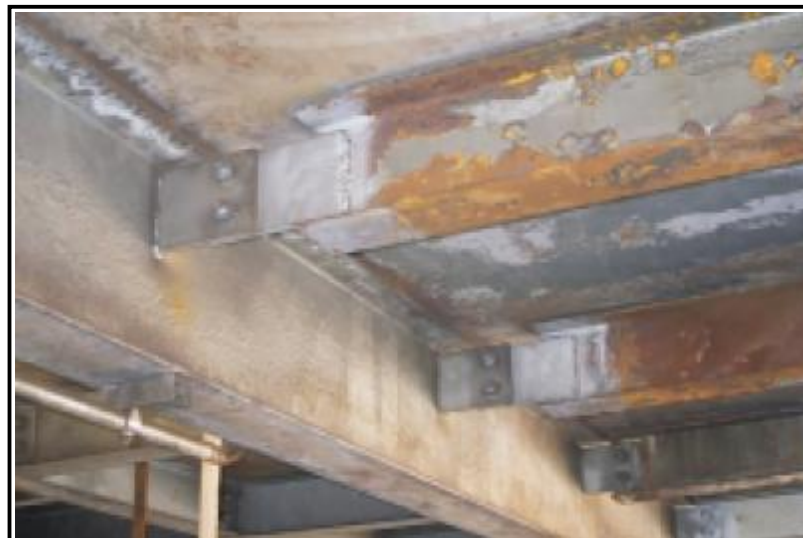
Category V4: Beam cleats (connection between beams) of questionable design.

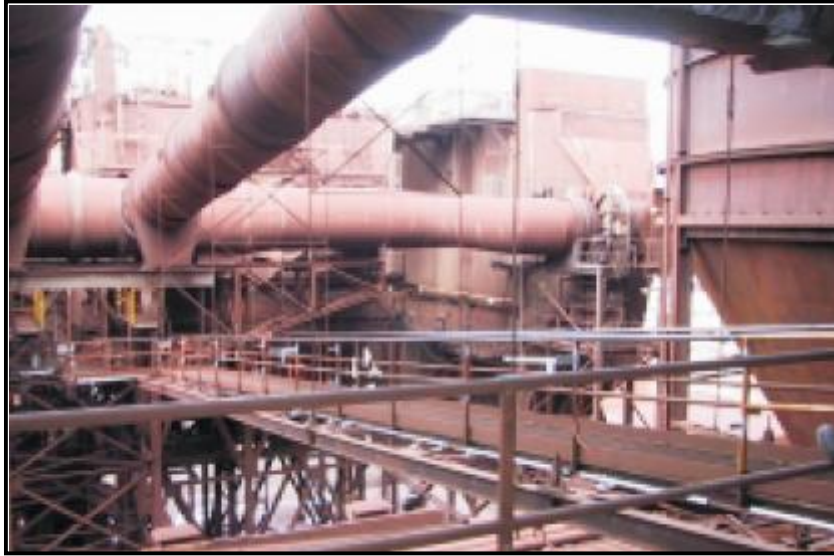
Category V3: Suspended walkway questionable. Needs further investigation.

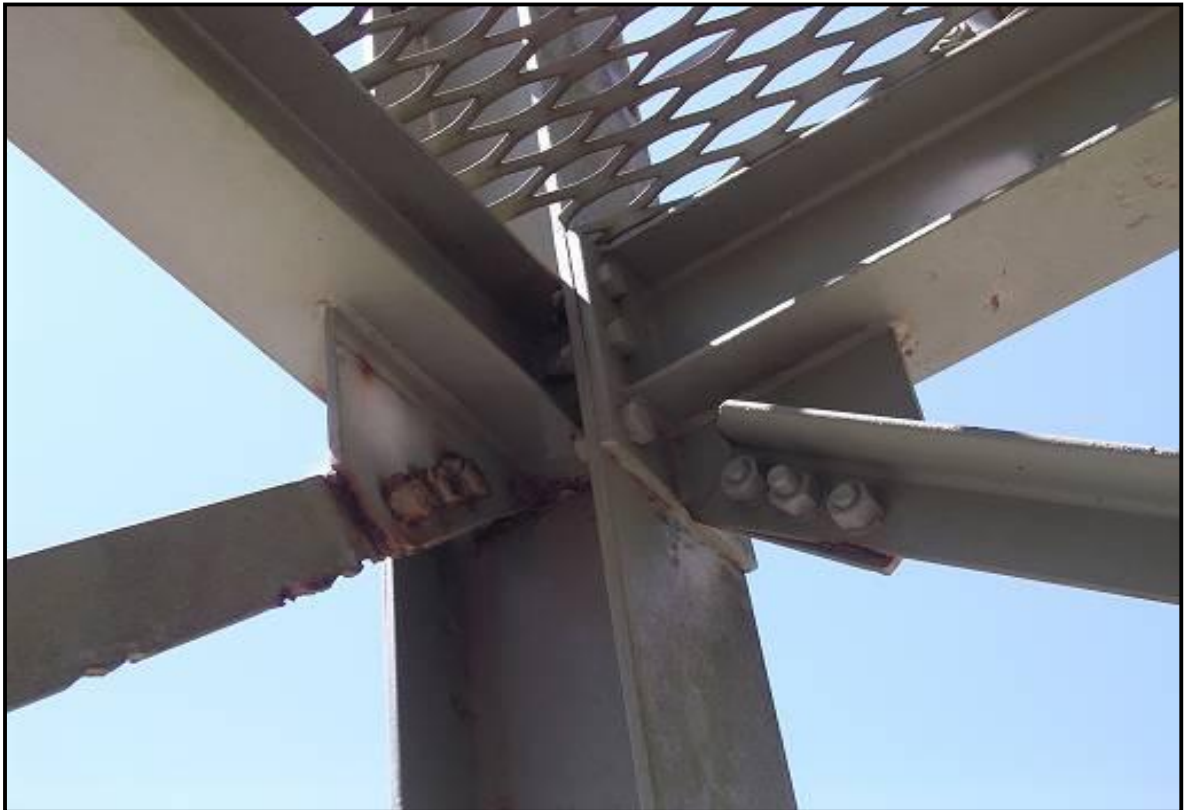
Structural Component	Silo Level 1 - SW corner top		
Picture taken	Yes / No	References	Photo 1

Structural Element	Category	Comments
Concrete	N/A	
Steel Corrosion	V2	Slightly corroded
Distortion/deflection	V1	
Bolt deterioration	V4	Nuts corroded severely. Requires further investigation.
Excessive vibration	V1	
Modifications	V1	
Design & construction	V1	
Worst Category	V4	Bolt deterioration Hard to detect consequence of failure considering support is not load bearing.
RISK ASSESSMENT RATING	HIGH	36

Bolts and nuts will need replacing. Bracing to be taken back to bare metal in area and painted. Structural engineer to approve work method statement as temporary removing wind bracing.

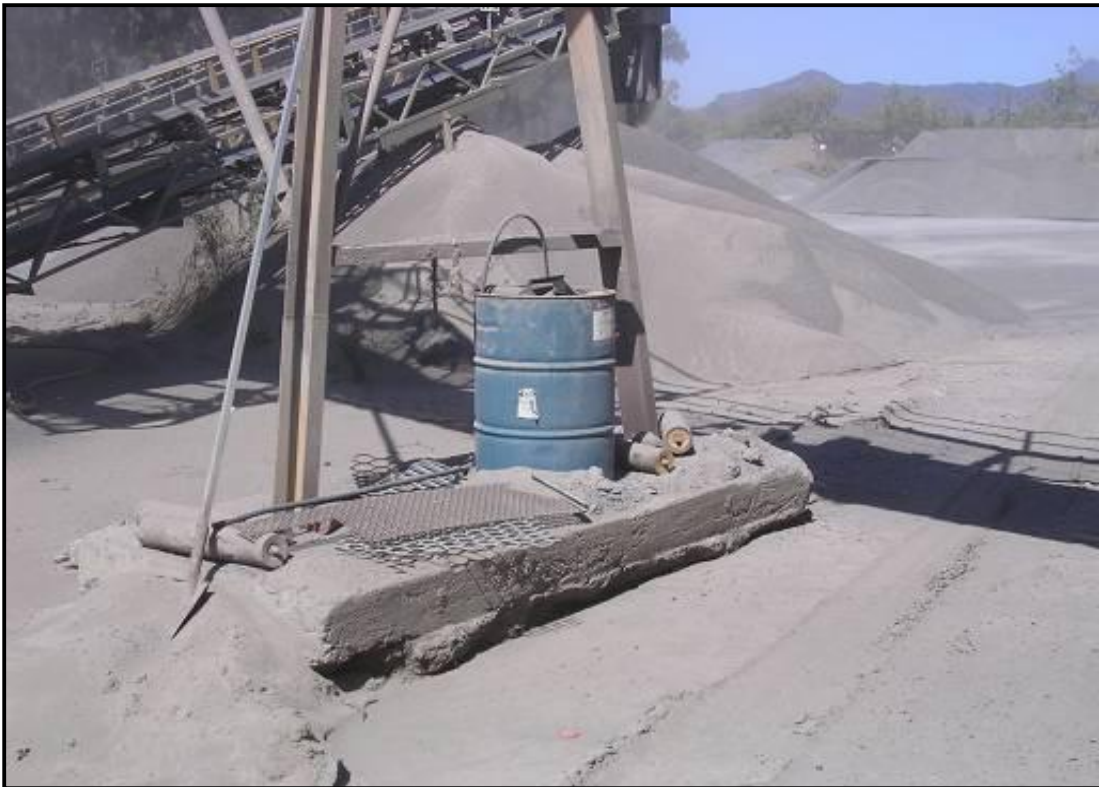
Structural Component	Conveyor 4 - centre supports		
Picture taken	Yes / No	References	Photo 2

Structural Element	Category	Comments
Concrete	N/A	
Steel Corrosion	V3	Slight corrosion with paint flaking
Distortion/deflection	V1	
Bolt deterioration	V1	
Excessive vibration	V1	
Modifications	V1	
Design & construction	V3	Support round has been affected by washout and may be undermining the supports rigidity.
Worst Category	V3	Failure unlikely to occur but would result in a major incident
RISK ASSESSMENT RATING	MEDIUM	32

Inspect foundations for settlement/movement.

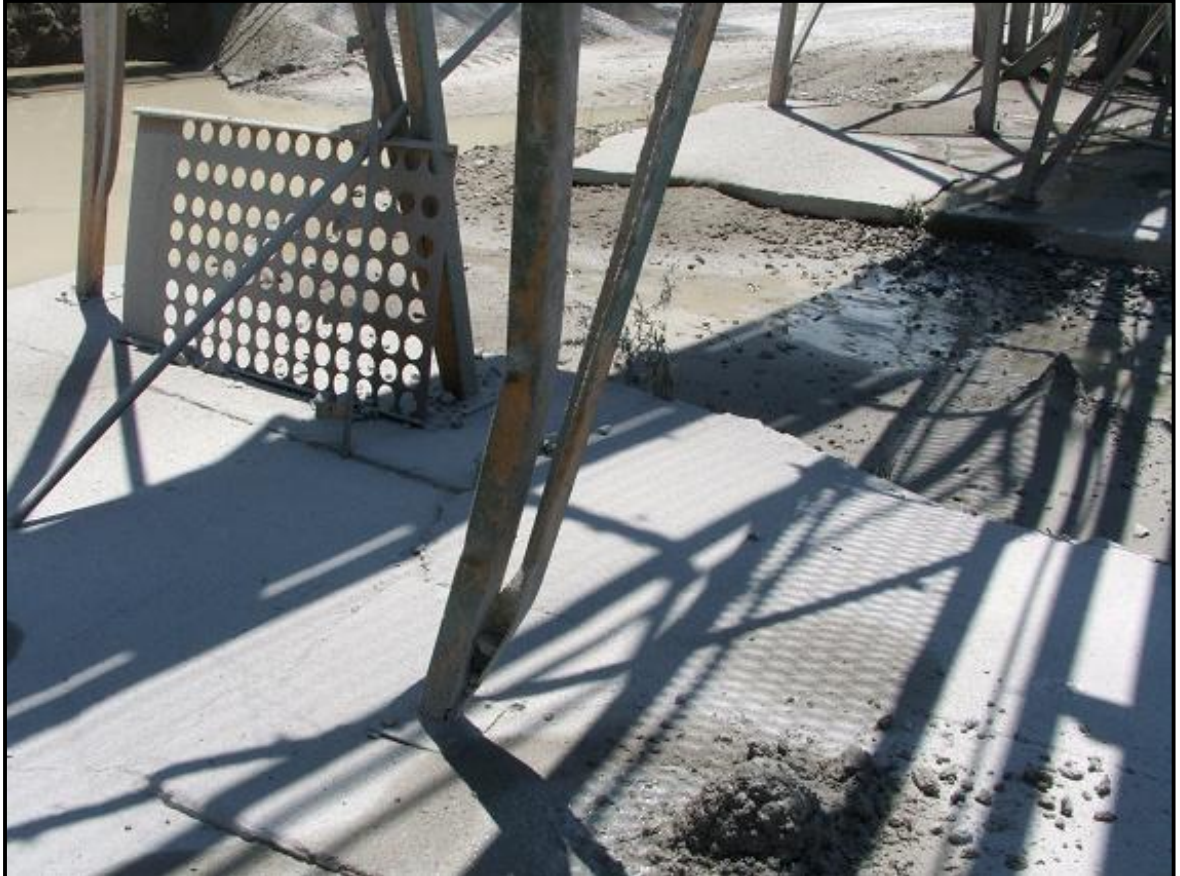
Structural Component	Conveyor 3 - centre support		
Picture taken	Yes / No	References	Photo 3

Structural Element	Category	Comments
Concrete	N/A	
Steel Corrosion	V3	Slight corrosion. Minimal paint remaining.
Distortion/deflection	V4	Damage - FEL contact?
Bolt deterioration	V3	Bolts may have been weakened due to impact. Some missing.
Excessive vibration	V1	
Modifications	V1	
Design & construction	V1	
Worst Category	V4	Possible failure. Potential to cause severe damage.
RISK ASSESSMENT RATING	HIGH	36

Members to be replaced. Bollards to be installed to prevent continuing damage to structure.
