Spherical Roller Bearings and Overhung Fans.

A case history in condition monitoring, root cause analysis, and design.

By Rod Bennett, Practices Leader Condition Monitoring. Silcar.

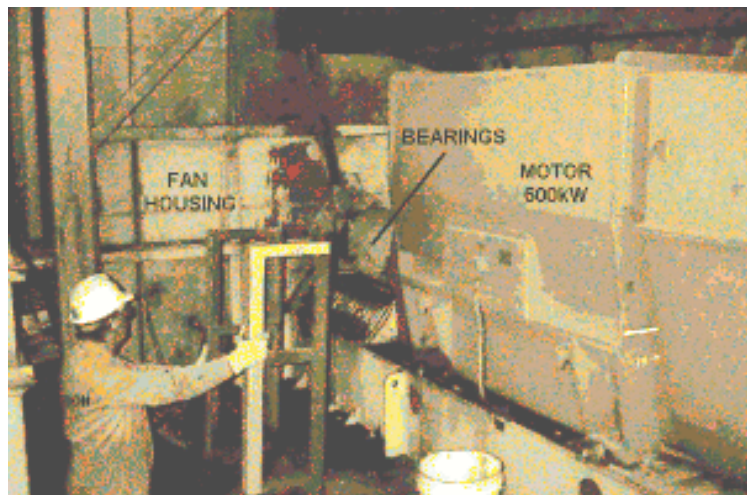
These fans are driven by 600kW, 6.6kV motors that are direct coupled to the fan shaft.

On average we would experience a bearing failure every 2 years. This would impact our Uptime through the initial process stoppage (4 hrs) and subsequent slow running (48 hrs).

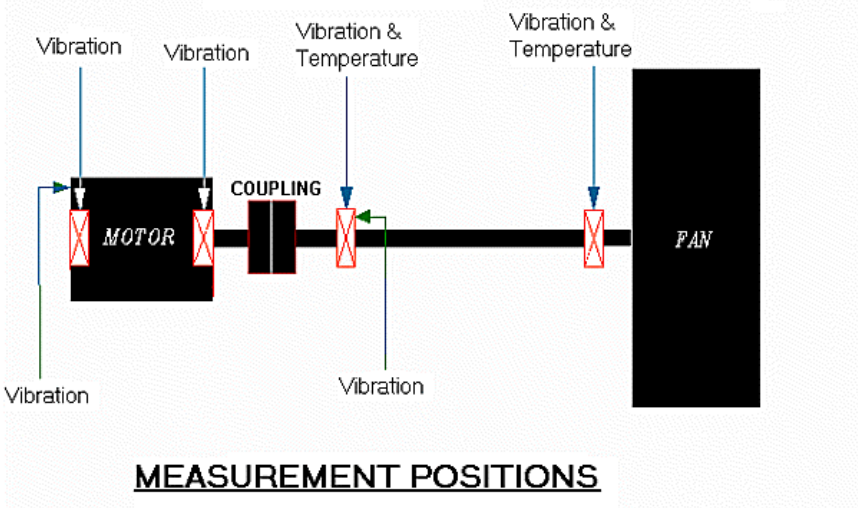
Our solution was to install an online vibration monitoring system. Our approach was to measure radial vibration at each bearing, and axial vibration on each shaft. We also measured temperature at each of the fan bearings as a safety net. We didn't want another flaming wreck.

In due course the monitoring system detected deterioration in the condition of one of the bearings. Deterioration was evident from an increase in the amplitude of the acceleration and demodulation parameters. This bearing was removed before it failed and the root cause investigation finally made some headway.

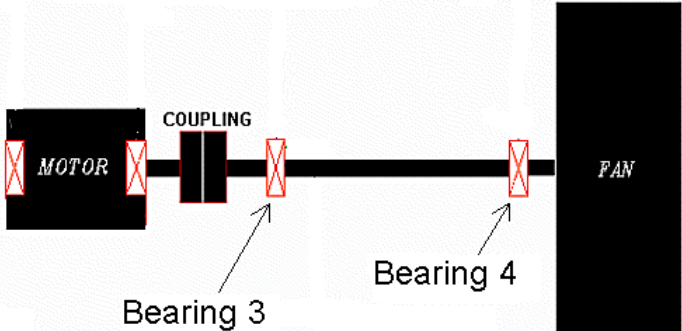
Before we get to the explanation of why this is so, ask yourself whether the fixed bearing in the diagram opposite should be bearing number 3 or bearing number 4.

The answer is Bearing 4, as it will have the highest radial load.

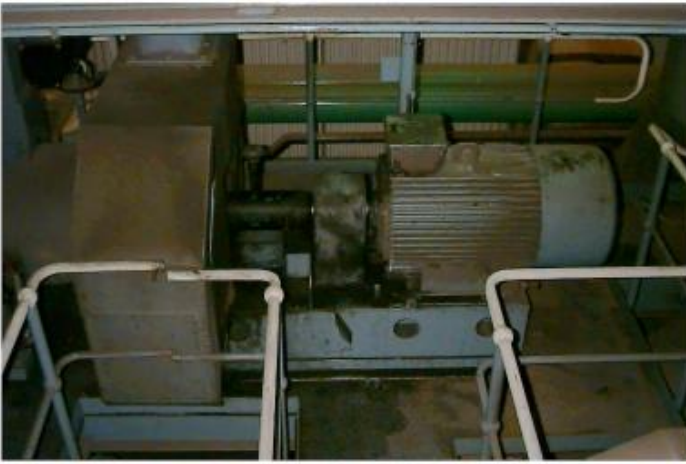
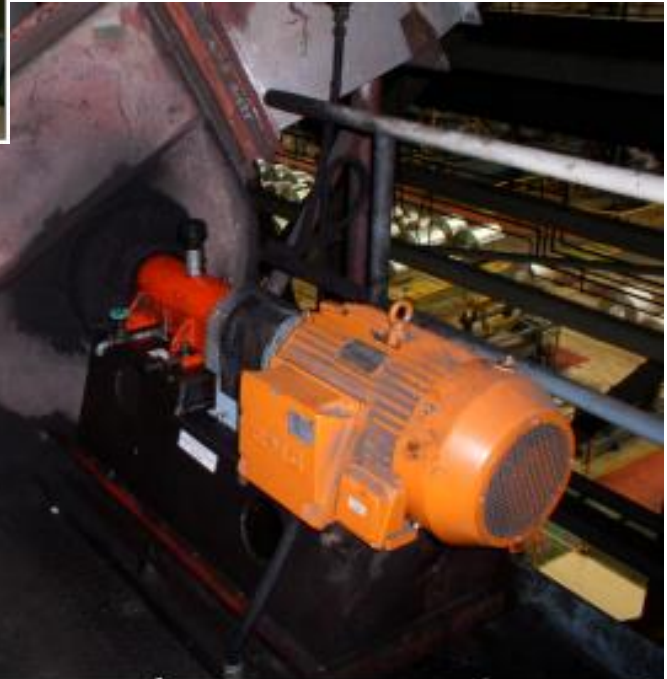
This particular fan was failing bearings every 3 months, on average. It has had only 1 failure since the new arrangement was installed many years ago, and this failure was as a result of a seal problem.

then the answer is to install a single line bored housing with 2 non self aligning bearings.
The SKF catalogue even says that these housings were developed for overhung fan applications.

There have been no bearing failures since the new housing arrangement was installed over 7 years ago. Provided we look after the lubrication, we expect that these bearings will run for many years yet.
