Industrial Maintenance Roundtable NSW
Common Interest Workgroup (CIWG) Report
from Meeting on Maintenance 7th May 2008

Maintenance and Reliability of Structures CIWG

This document is compiled from discussions during the NSW IMRt Common Interest
Workgroup (CIWG) on 7th May 2008.

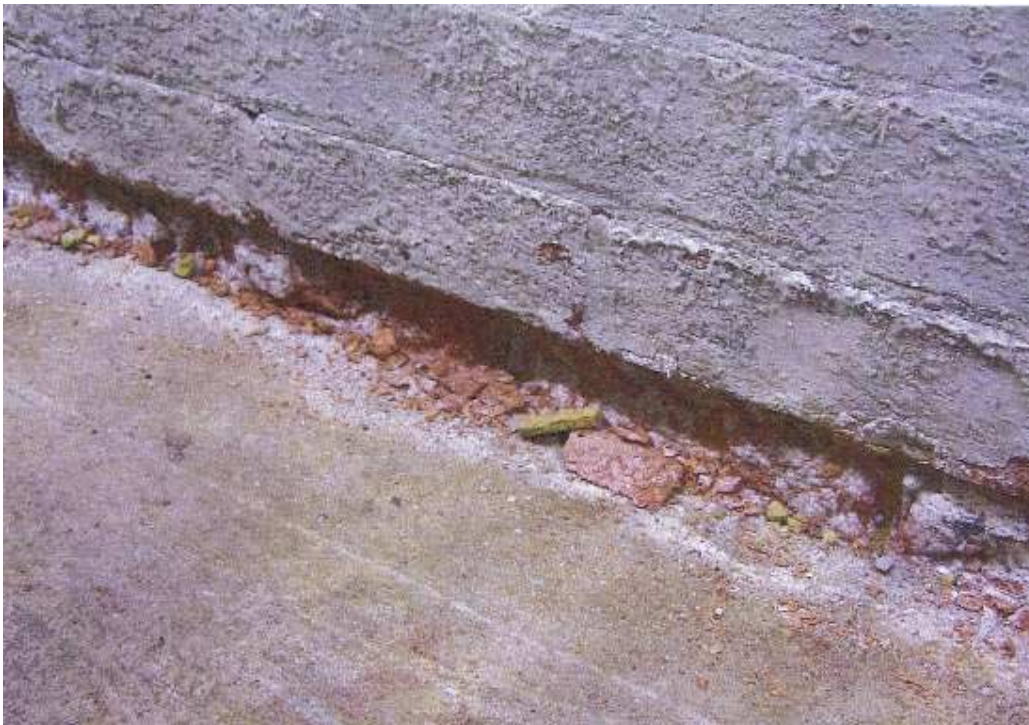
Craig from Delta asked about management of a Brick deterioration problem he has (see photo below). Mark from Bluescope suggested he had seen similar problems electrical substation building brick walls at his site. The issue only occurs on the lower courses of brickwork and appears to be salt buildup related. Some possible causes were discussed but the consensus was to involve brick specialist from brick suppliers or the Brick and Paver Institute.

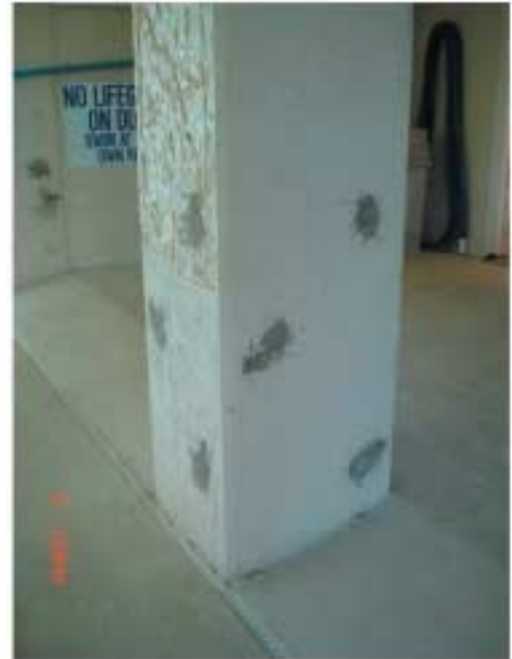
Finished Condominium Column with Galvashield CC's Installed.

Vector Galvashield CC embedded galvanic anodes are used to control on-going corrosion and to prevent the initiation of new corrosion activity in concrete structures. Galvashield CC anodes consist of a sacrificial zinc core that is activated by the surrounding specially formulated precast cementitious mortar. The cylindrical anode, available in a variety of standard sizes, is quickly and easily installed into concrete that is mechanically sound but has on-going corrosion activity. Once installed, the zinc core corrodes preferentially to the surrounding rebar, thereby providing galvanic corrosion control to the adjacent reinforcing steel. Custom size anodes are available for specific project needs.

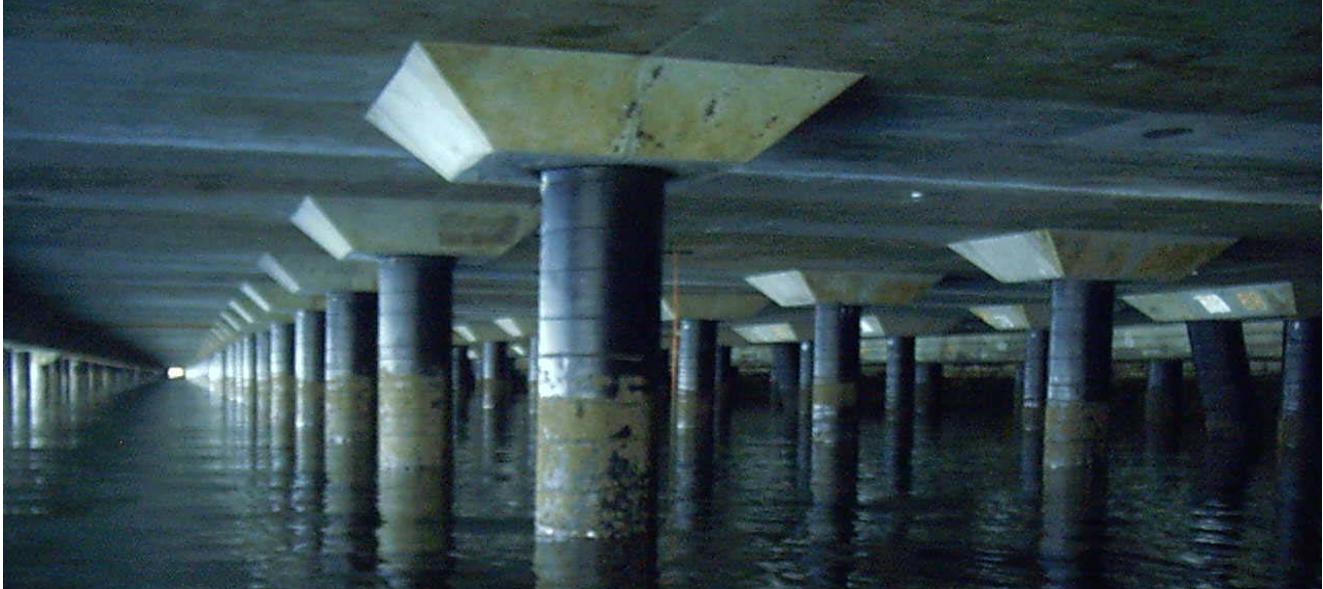
SEASHIELD SERIES 100

CYLINDRICAL STEEL PILE PROTECTION

CONSTRUCTION:

A HIGH DENSITY POLYETHELYNE OUTERCOVER FASTENED WITH SMARTBAND STRAPPING AND BUCKLES
